Manhole Inspection Summary

Manhole # S43E__079MH

Insp Date: **6/10/08 9:22 AM**

Location Address: **1622 e lombard st**

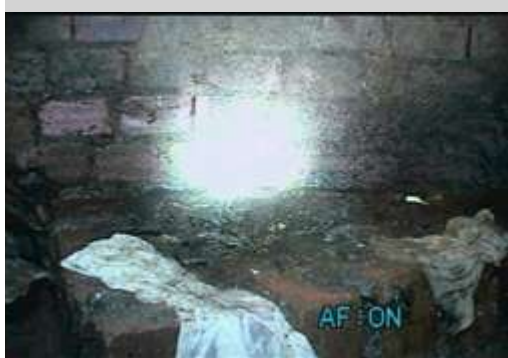
Misc

Condition: ☒ Sound ☐ Cracked ☐ Root Intrusion ☐ Deteriorated ☐ Leaks ☐ Debris

bench debris

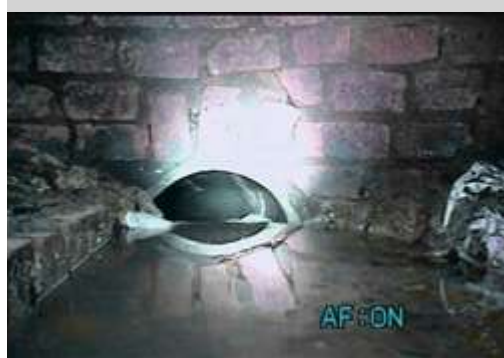
Defect 2

Condition: ☐ Sound ☐ Cracked ☐ Root Intrusion ☐ Deteriorated ☐ Leaks ☒ **Debris**

Channel Debris

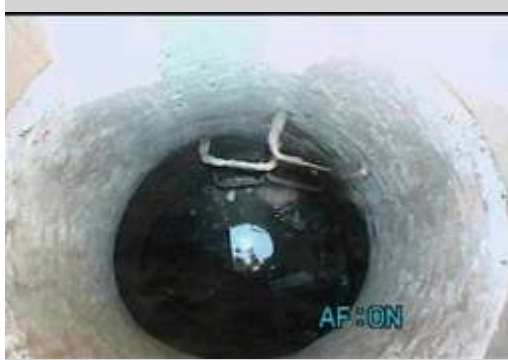
Defect 3

Count: **6** Missing: **2** ☒ **Corroded**

missing/Corroded steps

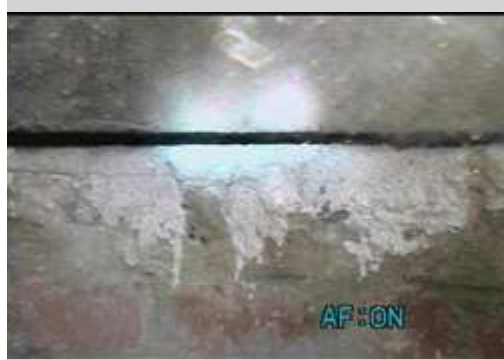
Defect 1

Condition: ☐ Sound ☒ **Cracked** ☐ Root Intrusion ☐ Loose Brick ☐ Deteriorated

Chimney cracked,
frame adj

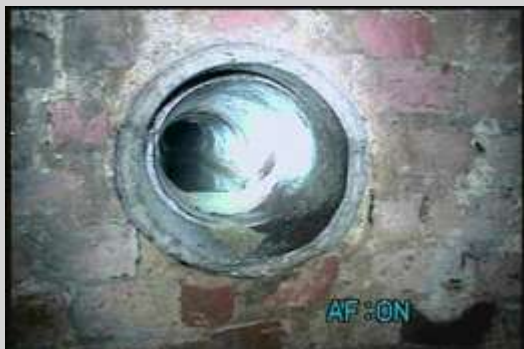
3 O'Clock Inflow

Pipe Height: 0 (in.) Direct
Pipe Material: **Clay** ☐ Pipe Lined
Invert Depth: 9.16 (ft.) Flow Characteristics: **Slow**
Deposits: ☐ None ☐ Mud ☐ Sludge ☒ **Debris** ☐ Grease
Silt Depth: 3 (in.) Deposits Extent: **Light**
Infiltration: **None** Pipe Seal Cond: **Unknown**

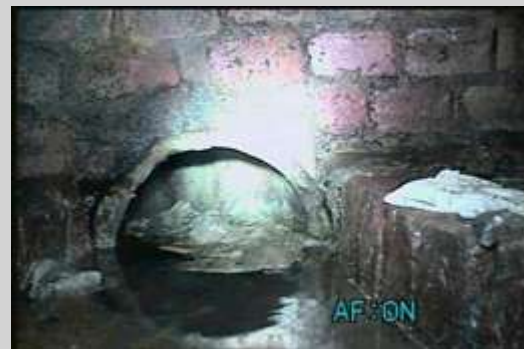
Drop In @ 3 OClock

Drop: **Outside Direct**
Angled: Reading: 0.00 (ft.)
Inv Depth: 11.07 (ft.)
Drop Condition: **Open**
